BIELA14-T Series Gen III LOV[™] Electric Fryer

Service Manual

Part Number: FRY_SM_8197548 08/2022

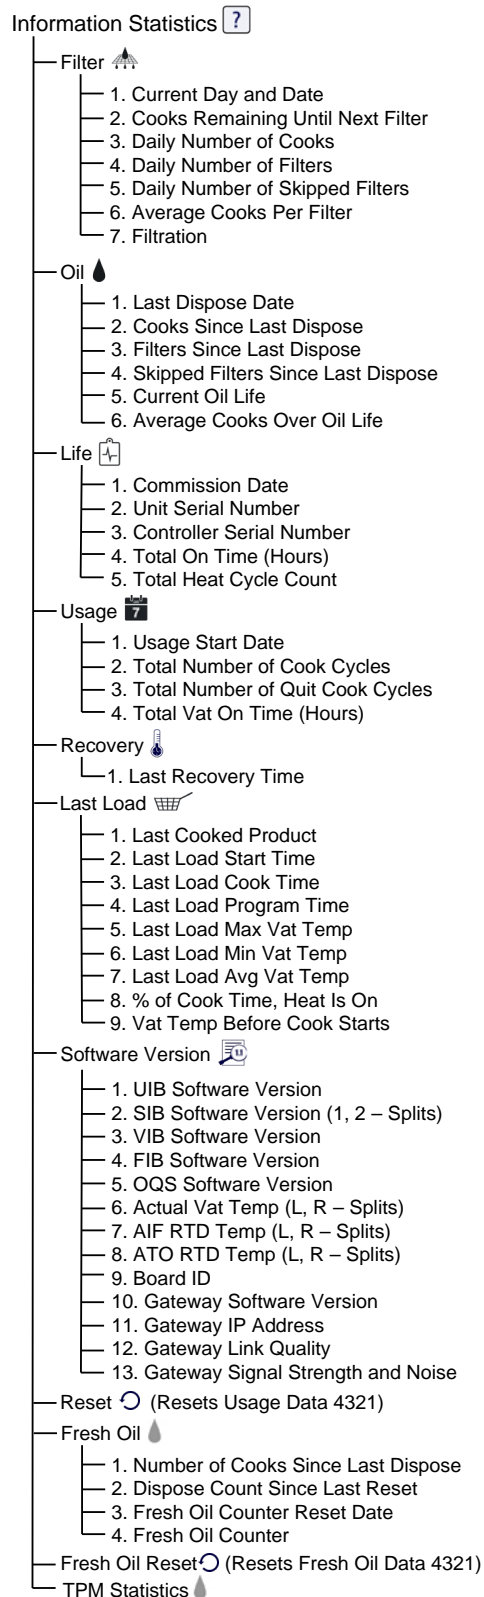
1.1.2 M4000 Information Statistics Menu Tree

Reflected below are the information statistics in the M4000 and the order in which the headings will be found in the controller.

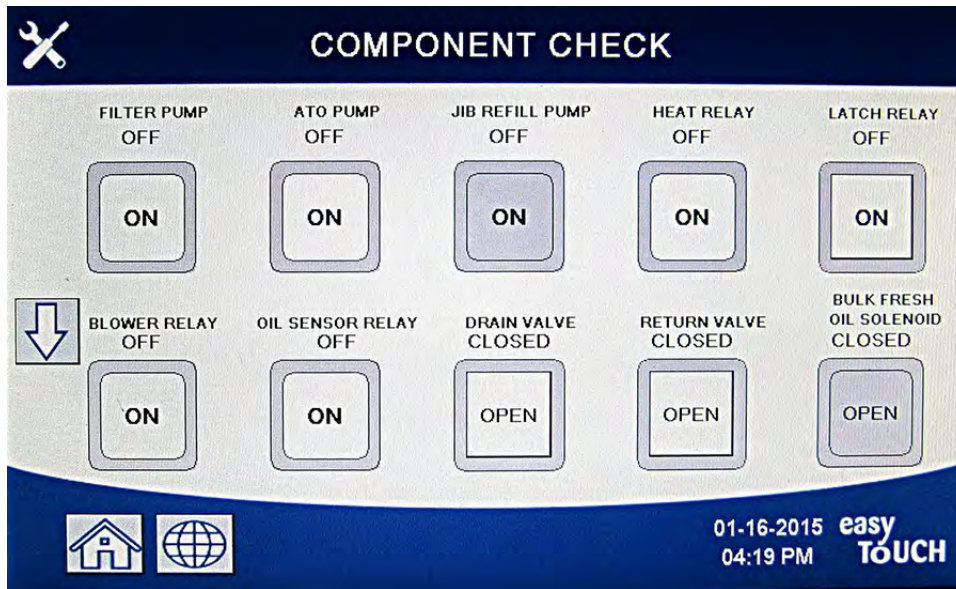
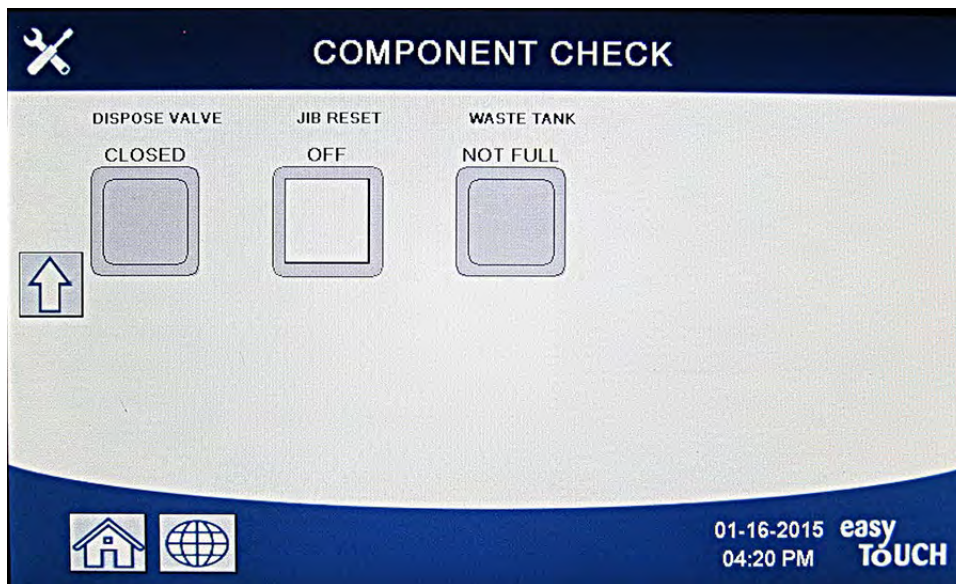
With the controller soft powered OFF, press the HOME button. Select Service, Service, Enter 9000, Select Tech Modes, and scroll down and select Component Check.

The component name is above each button. The status of the component is below the function. Pressing the button will change the status of the function to what is stated on the button. If the button is shaded that function is not available unless that function is enabled (such as bulk). The JIB reset button and Waste Tank full only displays the status of the switch.

Pressing the home button to exit the function will display driving valves to ensure all valves return to home state. Once completed the controller will display FILL VAT FROM DRAIN PAN? YES NO. Press YES to ensure that any oil in the filter pan is returned to the vat.

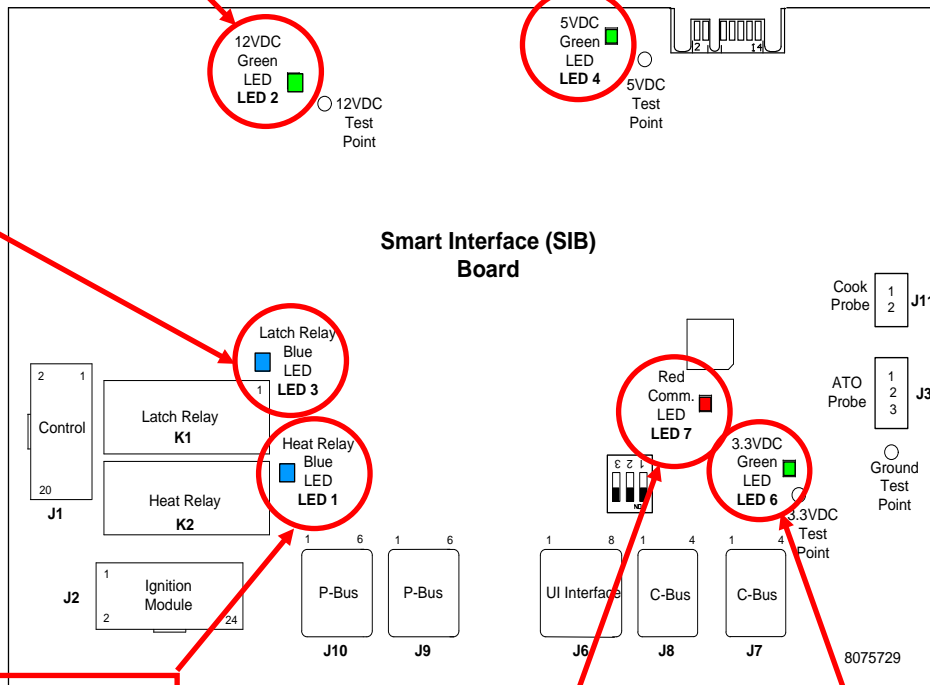
5VDC should be lit and bright at all times. If LED (4) is dim then something is pulling voltage down. Short to ground on 5VDC circuit will cause dim LED.

When UI is soft powered on this Latch Relay LED (3) will come on first confirming high limit is closed. The relay is a true latch circuit and when broken or turned off the heat relay will also turn off.

When UI calls for HEAT LED (1) will come on with the heat relay only after latch relay has been latched in. This LED will cycle with the call for heat.

Blinking red LED (7), (Heart Beat). This LED should be blinking and bright at all times when board is powered. The other green LED's being dim or off will cause this LED to be off.

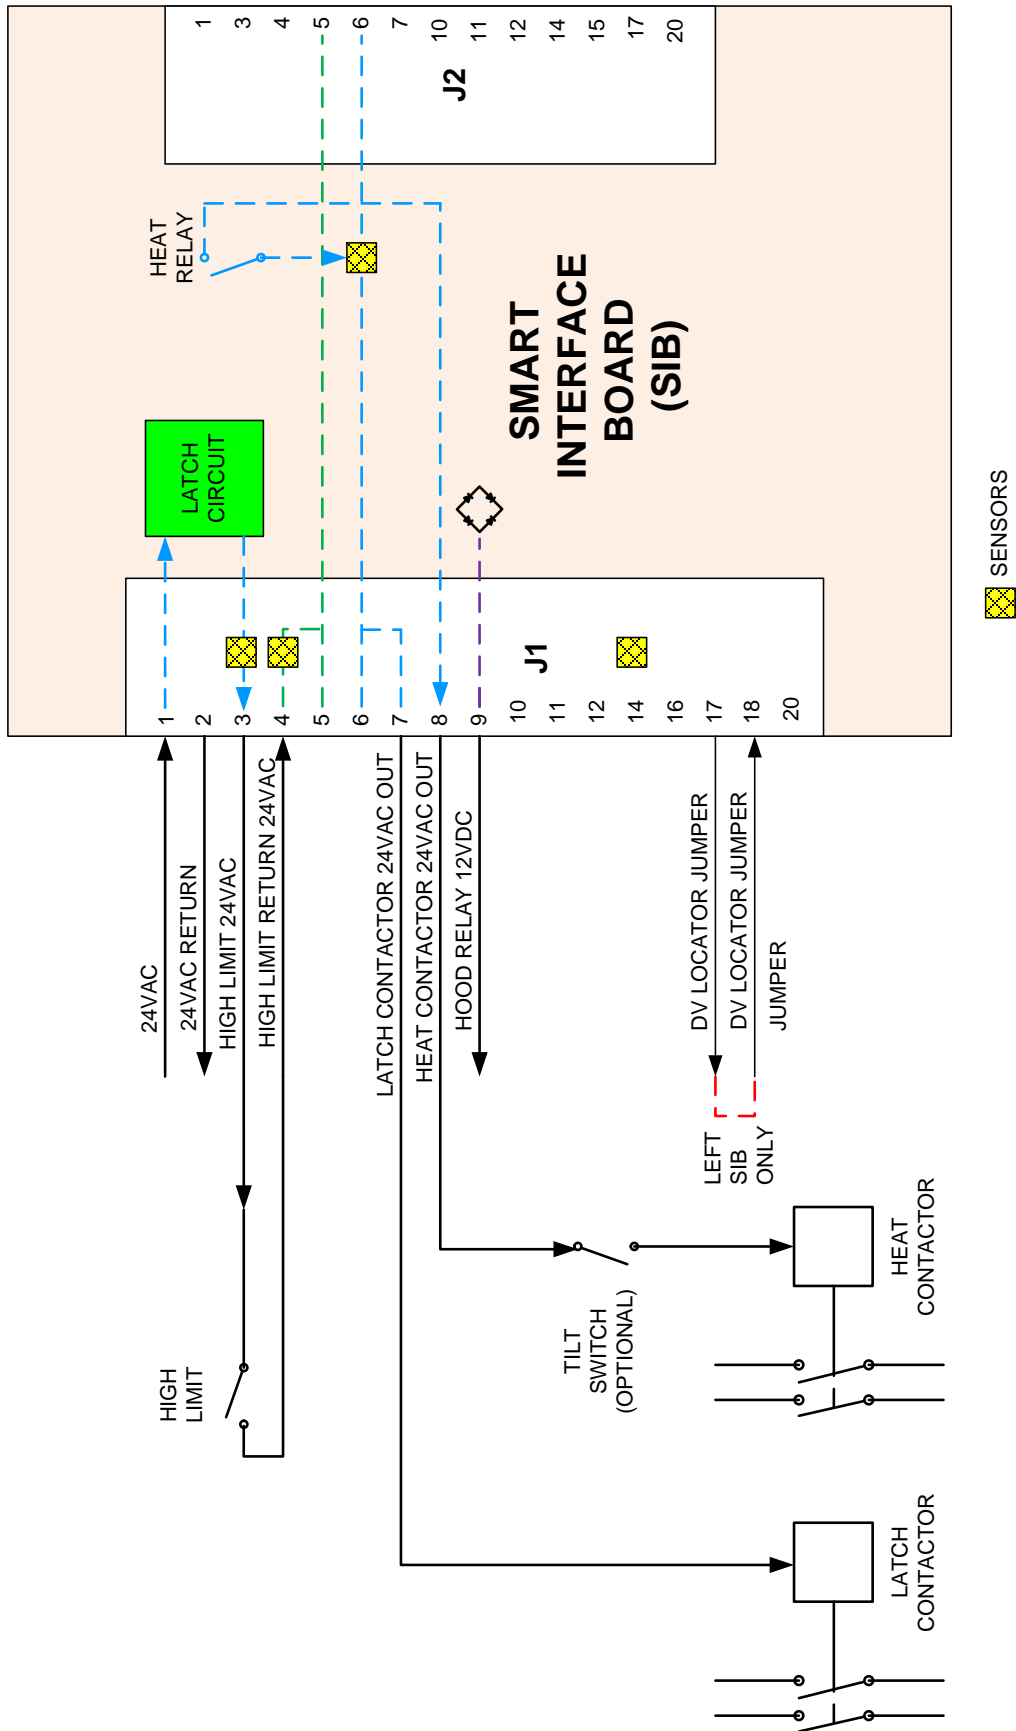
1.7.3 Full/Split Vat flow through the SIB (Smart Interface Board)

ELECTRIC SYSTEM

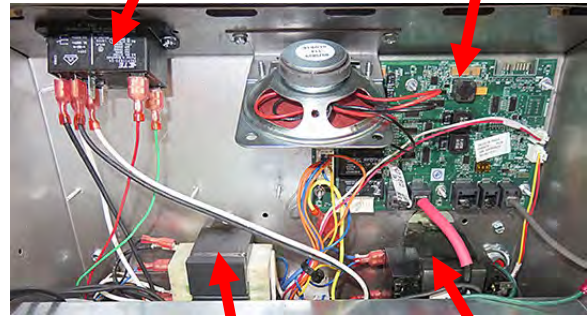
Figure 1

Filter Relay (Left Box Only);
Reset Switch Relay (Right Box Only) SIB

6. Reverse the procedure to install the replacement component. If replacing the SIB board, ensure the spacers behind the board are in place and the controller locator wire (if applicable) is attached to a stud.
7. Reverse above steps to reassemble, complete the replacement and return the fryer to service.

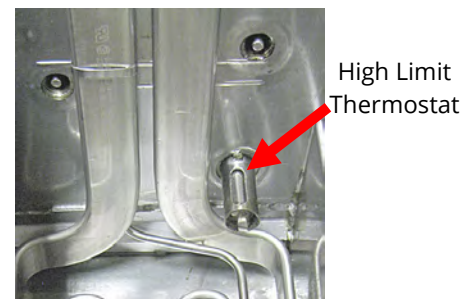
Figure 2

5. Carefully unscrew the high-limit thermostat to be replaced.
6. Apply Loctite® PST56765 pipe thread sealant or equivalent to the replacement part threads and screw the replacement part into the frypot. Torque the component to 180 inch-pounds.

7. Insert the leads into the 12-pin connector C-6 (see Figure 3). For full-vat units or the left half of a dual-vat unit (as viewed from the rear of the fryer) the leads go into positions 1 and 2 of the connector. For the right half of a dual-vat unit (as viewed from the rear of the fryer), the leads go into positions 7 and 8. In either case, polarity does not matter.

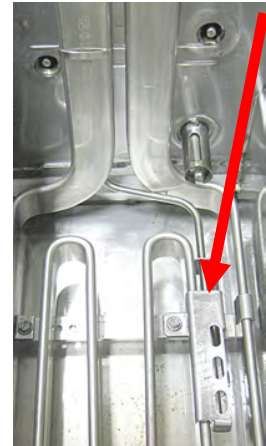
Figure 3 Temperature Probe

6. Remove the securing probe bracket and metal tie wraps that secure the probe to the element (see Figures 4 and 5). Remove the ground clip on the probe shield.

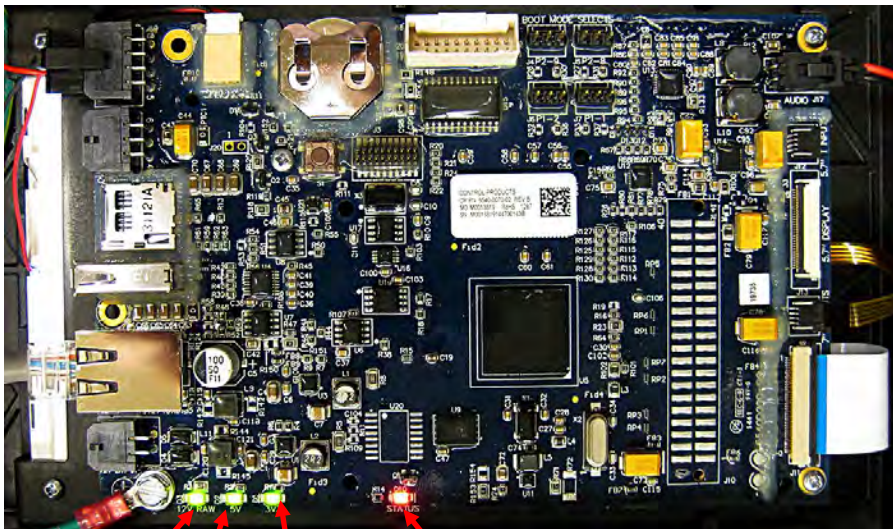
Figure 7

There are four (4) LED status lights on the rear of the controller which provide a quick method to verify power and touch screen functionality on the M4000 controller.

To verify that the FQ4000 has power and the touch screen is functional, remove the 2 screws attaching the controller to the bezel. Lower the controller to view the LED's on the rear of the controller board. Verify that the three (3) green LED's are illuminated which indicate that 3V, 5V and 12V power is present on the controller. These should be illuminated at all times. Pressing anywhere on the front of the touch screen will illuminate the red LED STATUS (see Figure 7). The red LED will also illuminate momentarily during power up.

- 12V from SIB
- 5V from SIB
- 3V from power supply on UIB
- When the touch screen is pressed, the STATUS LED illuminates RED.

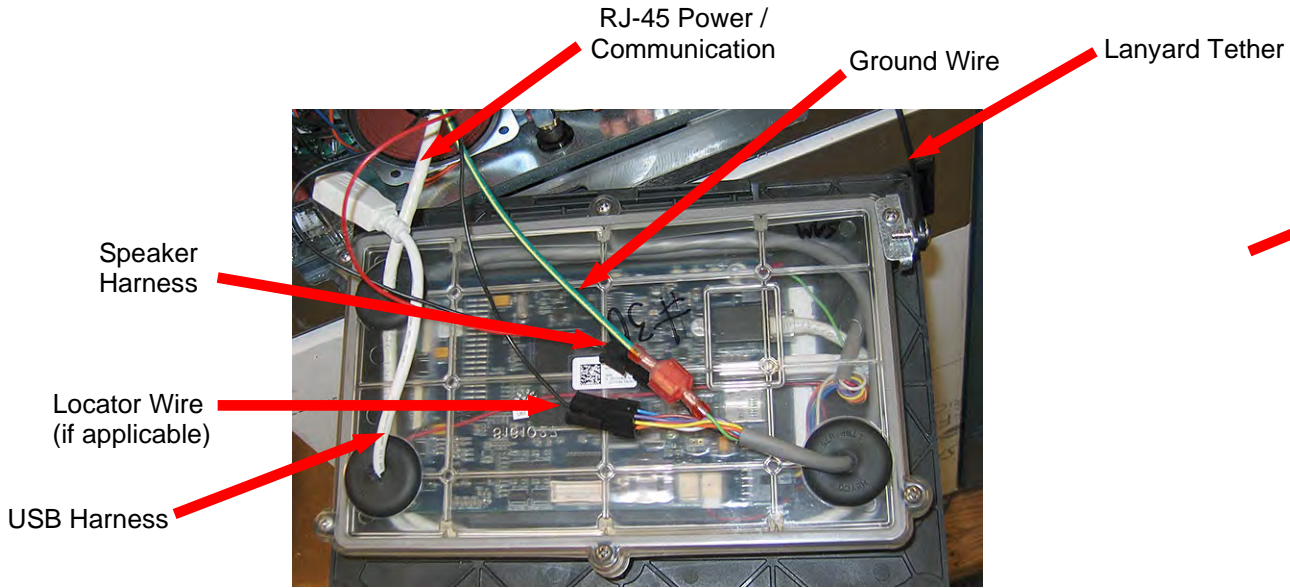
Figure 8

1. **Disconnect the fryer from the electrical power supply. The fuse located at the bottom of the control box can be removed to remove power from individual control boxes.**
2. The controller is held in place by two screws in upper corners.
3. Remove the two screws from the upper corners of the controller.
4. Slide the controller up and it will swing open from the top.
5. The controller will slide up through the protective cage.
6. Disconnect the RJ45 cable from the SIB board first.
7. Disconnect the other cables from the connectors on the back of the controller marking their position for reassembly.
8. Disconnect the lanyard tether.
9. Remove the controller. The controller will slide up and out of the controller protector cage.

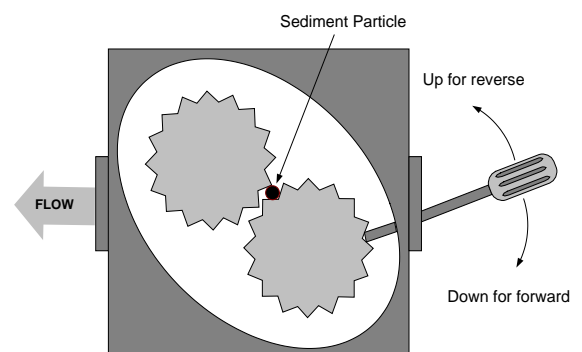
Figure 12

A pump seized by debris or hard shortening can usually be freed by manually moving the gears with a screwdriver or other instrument as illustrated in Figure 12. **Ensure power to the pump motor is off before trying this.**

1. Disconnect power to the filter system.
2. Remove the input plumbing from the pump.
3. Use a screwdriver to manually turn the gears (see Figure 12).
 - Turning the pump gears backwards will release a hard particle and allow its removal.
 - Turning the pump gears forward will push softer objects and solid shortening through the pump and allow free movement of the gears.

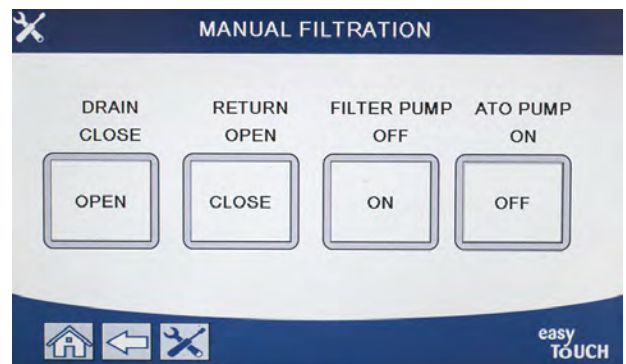
Figure 13

The controller displays the current state of the valves and pump under the titles (see Figure 13). Pressing the buttons will perform the action inside the button.

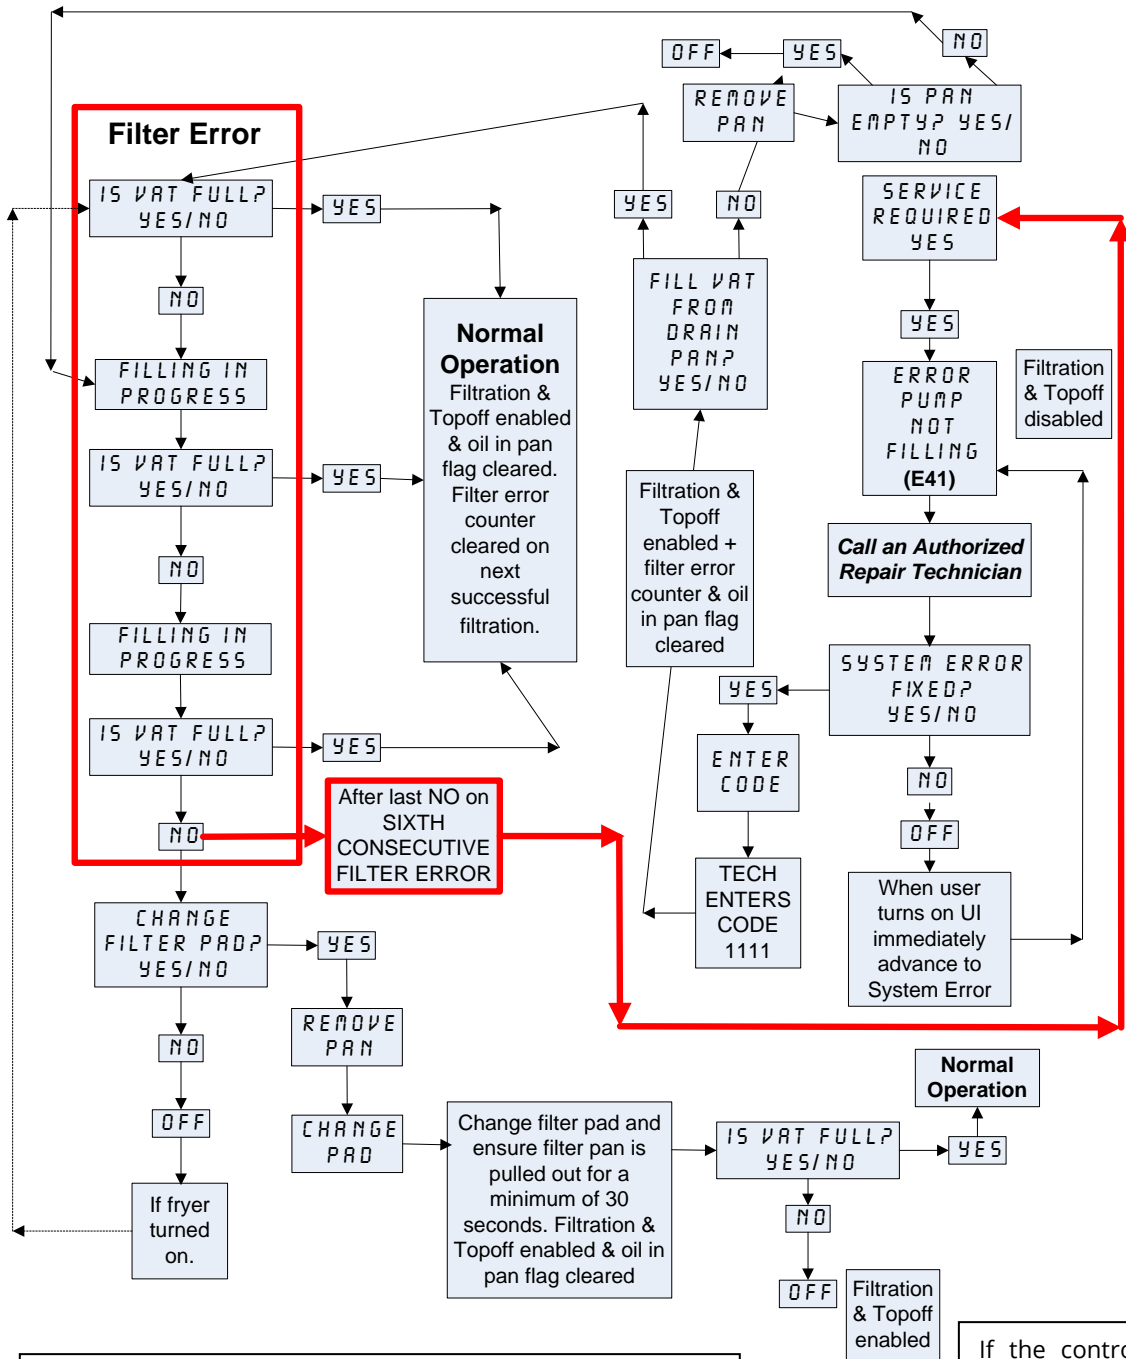
1.10.6 M4000 Filter Error Flowchart

This flowchart is followed in all the places where the software displays "IS VAT FULL" except Maintenance filtration. In Maintenance filtration, "IS VAT FULL" message will be in a loop, until user press YES.

This chart follows the process of clearing a filtration issue. The prompt is displayed when any of the following occur:

1. a clogged filter pad,
2. a clogged pre-filter,
2. a tripped or defective filter pump,
3. a leaky O-ring on the pick-up tube,
4. a failed drain valve/actuator, or
5. a failed return valve/actuator.

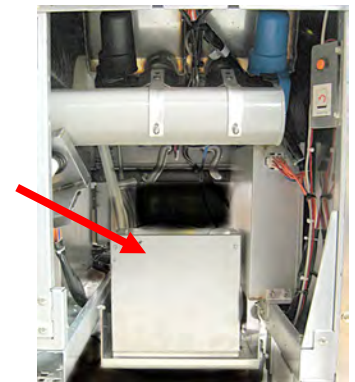
The 24VAC transformer in the left component box powers the fresh oil solenoid for bulk oil.

Disconnect the fryer from the electrical power supply. Locate the FIB box (see Figure 17 in section 1.11), behind the oil reservoir). Remove the cover of the FIB box to expose the power supply, FIB board and optional SUI communication board (see Figure 21). Mark and unplug any wires or harnesses. Replace the defective component and reattach all wires or harnesses. Replace the cover. Once replaced, **CYCLE POWER TO ENTIRE FRYER SYSTEM**. See section 1.13 to cycle control power. Check software version and if necessary update the software. If a software update is necessary, follow the instructions to update the software in section 1.15.

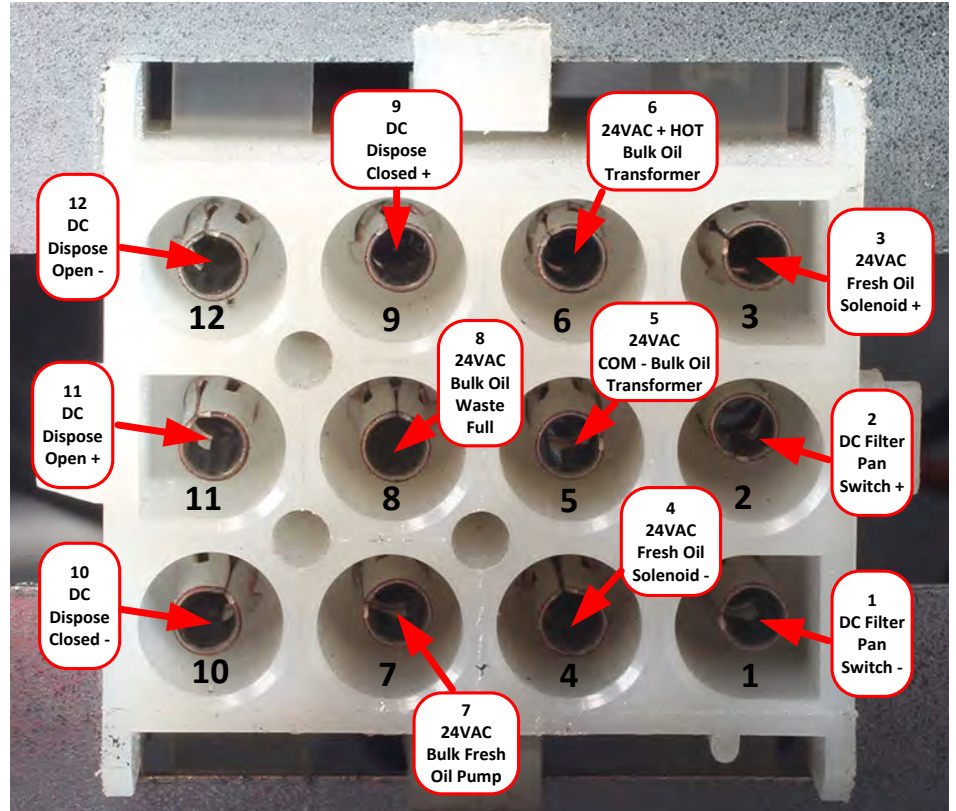
Figure 18

Use these test points for troubleshooting.

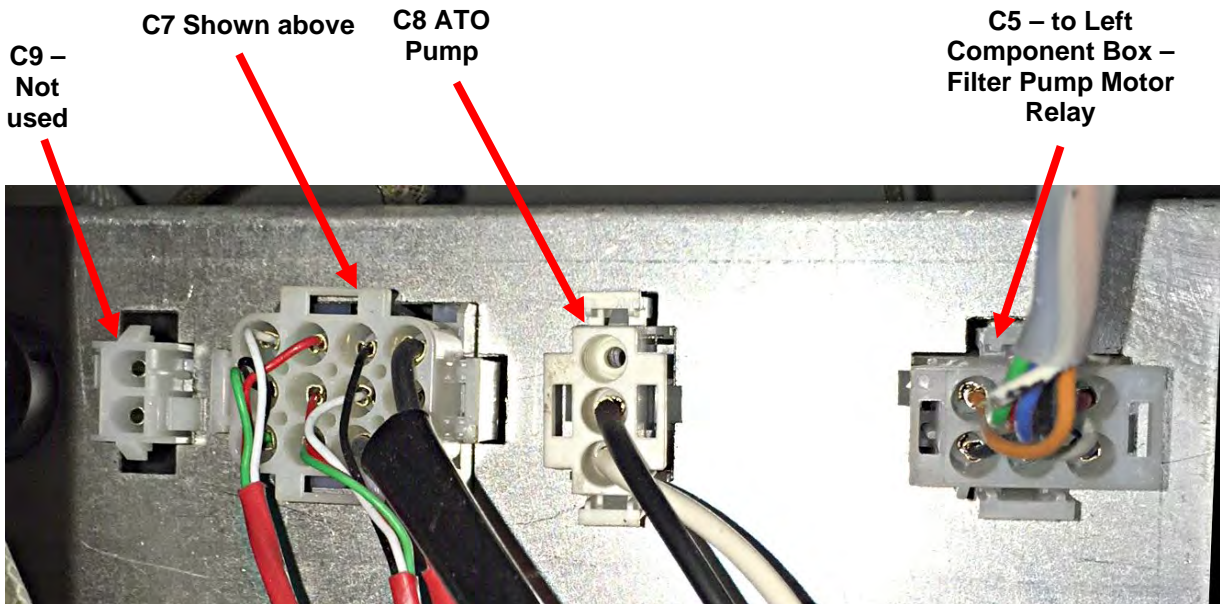
Figure 19

1.11.2.2 Connections on rear of FIB (Filter Interface Board) box

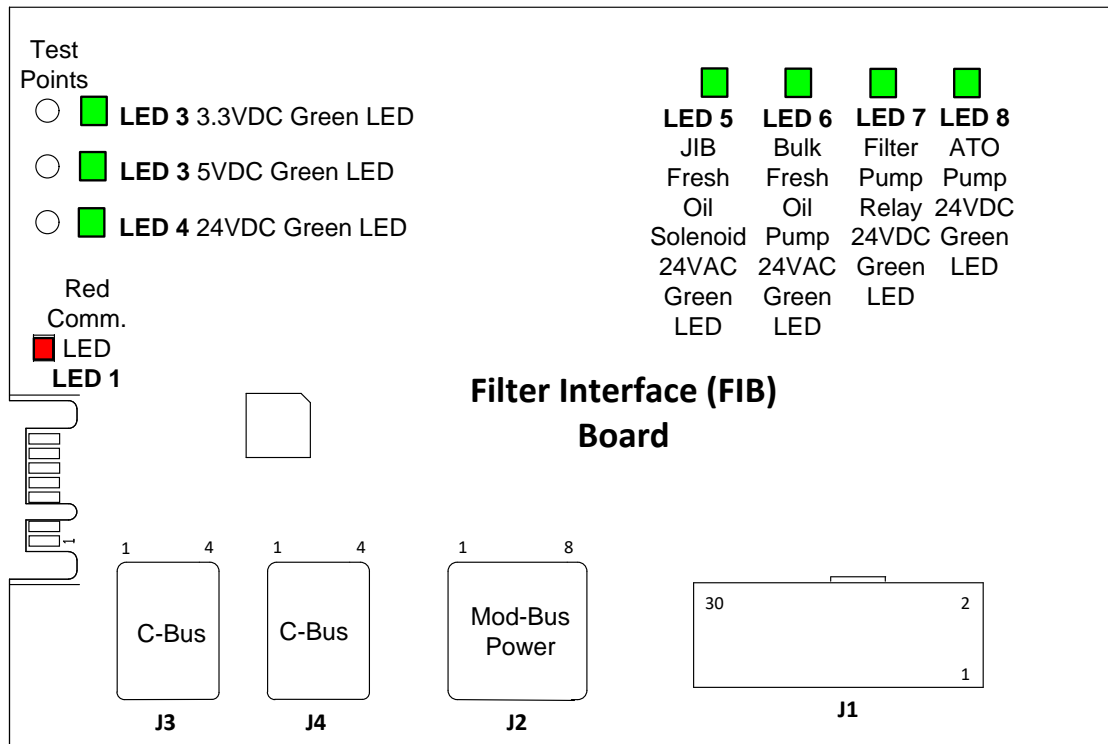
Figure 20

1.11.3 FIB (Filter Interface Board) LED's and Test Points

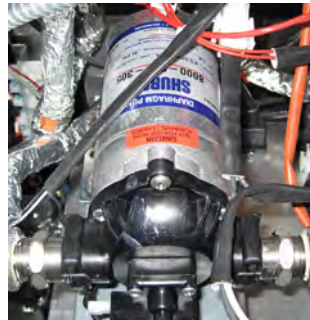
Figure 22

Disconnect the fryer from the electrical power supply. Locate the ATO pump (see Figure 22), behind the ATO box. Mark and unplug any wires or harnesses. Press down from the top on the quick disconnects to release the plumbing (see Figure 23). The plumbing can be pulled from the pump. Loosen the four nuts attaching the pump to the pump tray. Disconnect the electrical connection. Replace the defective component and reverse above steps. Once replaced, reconnect the power.

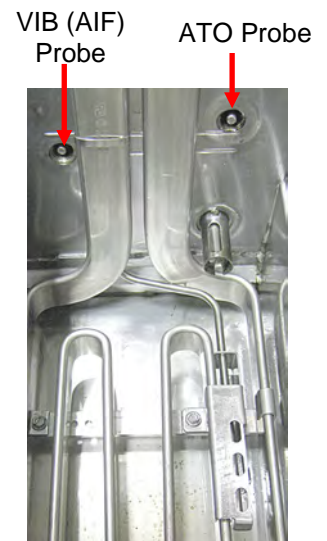
Figure 24

1. Disconnect the fryer from the electrical power supply and reposition it to gain access to the rear of the fryer.
2. Remove the associated side panel, if replacing an outside probe, to gain access to probe harness.
3. Drain cooking oil below the level of the probe to be replaced.
4. Disconnect the component wires as follows:
 - a. If replacing the ATO probe, disconnect them from SIB board.
 - b. If replacing the VIB (AIF) probe, use a paperclip to push pins from the J1 connector on the VIB board.
5. Unscrew the probe from the frypot.
6. Apply Loctite® PST56765 pipe thread sealant or equivalent to the replacement part threads and screw the replacement part into the frypot. If replacing an ATO or VIB probe **ensure the probe is flush with the side of the vat** prior to tightening. Torque the component to 180 inch-pounds.
7. Reverse steps 1 through 5 to complete the procedure.

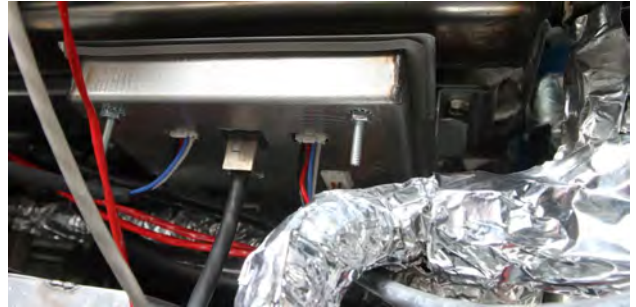
Figure 25

The VIB (Valve Interface Board) controls the actuators that open and close the drain and return valves. The VIB boards are located inside a protective housing under each frypot (see Figure 25).

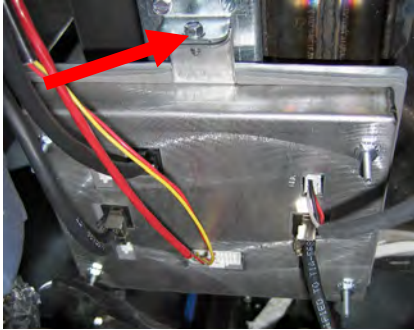
Figure 27

Disconnect the fryer from the electrical power supply. Locate the VIB (valve interface board) to be replaced under a frypot. Mark and unplug the harnesses. The VIB assembly is held in place with one screw (see Figure 27). Remove the screw and the assembly drops down (see Figure 28) and the tab slides out of the bracket attached to the frypot (see Figure 29). Reverse steps to reassemble, ensuring that the new VIB assembly slides into the slot in the bracket. Once complete, **CYCLE POWER TO ENTIRE FRYER SYSTEM**. See section 1.13 to cycle control power. Check software version number and if necessary update the software. If a software update is necessary, follow the instructions to update the software in section 1.15.

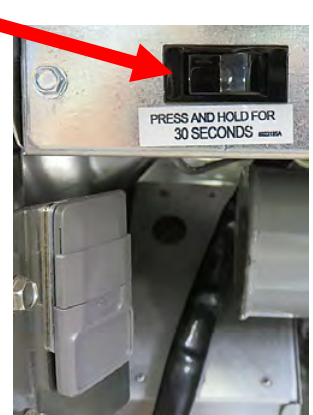
Figure 31

The control power switch is a rocker switch, located on the front of the left control box above the USB port (see Figure 31), that controls all power to all the controllers and boards in the fryer. It is necessary to power cycle all power after replacing any controller or board and after any setup change. Turn off the switch for **thirty (30) seconds** when cycling the control power to ensure power has sufficiently drained from boards.

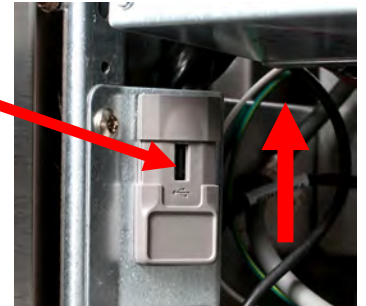
Figure 32

6. Press the TECH MODES button.
7. Press the down arrow.
8. Press the SOFTWARE UPGRADE button.
9. Controller displays INSERT USB.
10. Open the far-left cabinet door and slide the USB cover up (see Figure 32).

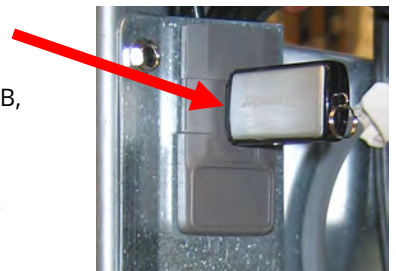
Figure 33

11. Insert the USB flash drive (see Figure 33).
12. The controller displays IS USB INSERTED? YES NO
13. Press the YES button after the USB flash drive is inserted.

7. Press the USB – MENU OPERATION button.
8. Press the COPY MENU FROM USB TO FRYER button.
9. The controller displays INSERT USB.
10. Open the far-left cabinet door and slide the USB cover up (see Figure 33).

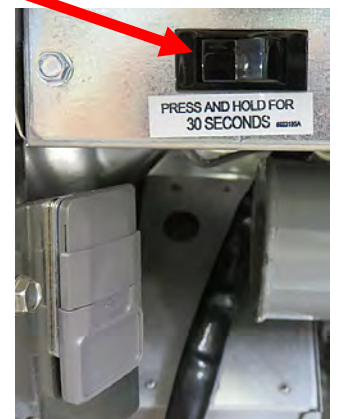
Figure 34

25. Cycle the fryer control power using the switch on the front of the left contactor box (see Figure 34). **ENSURE THE SWITCH IS TURNED OFF FOR 60 SECONDS.**
26. While the fryer is rebooting some controllers may take up to 10 minutes to reboot as the software is loading.
27. Once all controllers have returned to the power standby switch, go to the next step.
28. **VERIFY** software update by pressing the information (?) button; press the down arrow; press the SW version button. The controller displays INTIALIZING. Ensure that the M4000(UIB)/VIB/FIB/SIB software versions have updated.

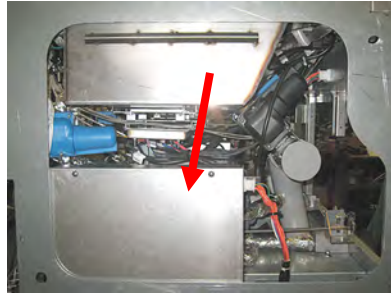
Figure 35

1. Disconnect the fryer from the electrical power supply.
2. Relocate the fryer if necessary.
3. If replacing the hood relay remove the left side of the fryer.
4. Locate the contactor box.
5. Remove the two screws securing the cover of the contactor box cover from the contactor box (see Figure 35).
6. Remove the cover to expose the interior of the contactor box (see Figure 36).
7. The contactors and relays are held on by threaded pin studs so that only removal of the nut is required to replace the component.
8. Replace the component(s) marking the wires to ease reassembly.
9. After performing necessary service, reverse steps to return the fryer to complete installation and return to operation.

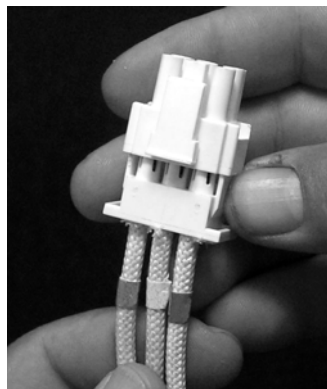
Figure 37

1. Perform steps 1-4 of section 1.8.5, *Replacing the Temperature Probe*.
2. Disconnect the 12-pin connector C-6 wire harness containing the probe wiring, attached to the element that is being replaced. Locate the red, black, (or yellow) and white wires of the temperature probe to be replaced. Note where the leads are connected prior to removing them from the connector.
3. Using a pin pusher, disconnect the probe wires from the 12-pin connector.
4. In the rear of the fryer disconnect the 6-pin connector for the left element (as viewed from the front of the fryer) or the 9-pin connector for the right element attached to the contactor box. Press in on the tabs on each side of the connector while pulling outward on the free end to extend the connector and release the element leads (see Figure 37). Pull the leads out of the connector and out of the wire sleeving.

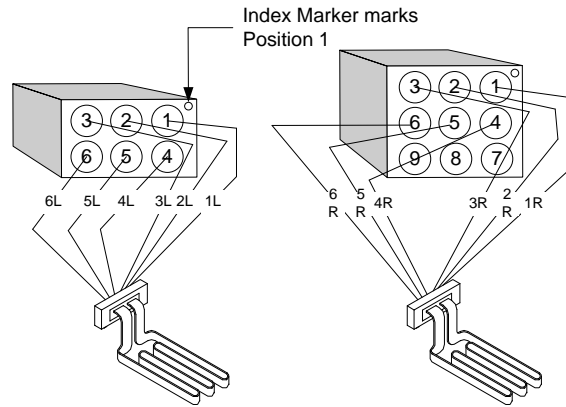
Figure 38

5. Raise the element to the full up position and support the elements.
6. Remove the hex head screws and nuts that secure the element to the tube assembly and pull the element out of the frypot. **NOTE:** The nuts inside the tube can be held and removed using the RE element tube nut spanner, PN# 2304028. Full-vat elements consist of two dual-vat elements clamped together. For full-vat units, remove the element clamps before removing the nuts and screws that secure the element to the tube assembly.
7. If applicable, recover the probe bracket and probe from the element being replaced and install them on the replacement element. Install the replacement element in the frypot, securing it with the nuts and screws removed in Step 6 to the tube assembly. Ensure the gasket is between the tube and element assembly.

- Route the element leads through the element tube assembly and into the wire sleeving to prevent chafing. Ensure that the wire sleeving is routed back through the Heyco bushing, keeping it clear from the lift springs (see photos below). Also ensure that the wire sleeving extends into the tube assembly to protect the edge of the tube assembly from chafing the wires. Press the pins into the connector in accordance with the diagram below and close the connector to lock the leads in place. **NOTE:** It is critical that the wires be routed through the sleeving to prevent chafing.

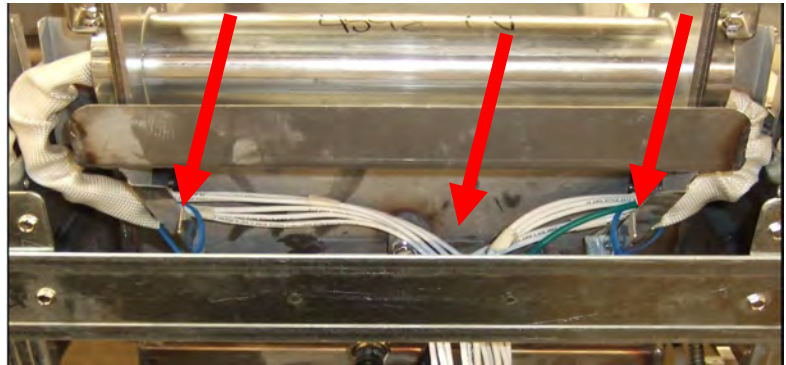
Figure 39

Full vat element wire routing

Pull the element wires through the bushings on either side of the frypot and down the back. Element wires should be routed to the right of the ATO temperature probe on the back wall of the frypot.

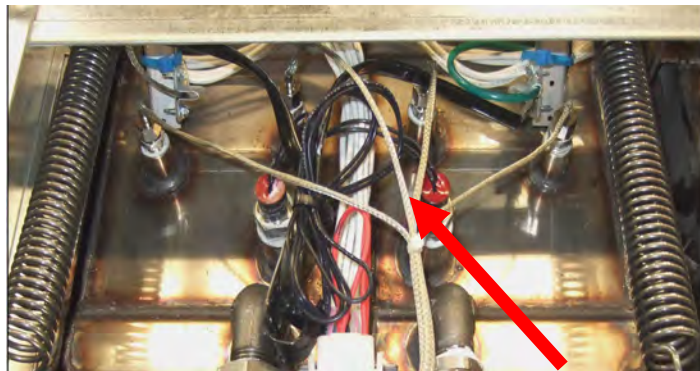
Figure 40

Dual vat element wire routing

Pull the element wires through the bushings on either side of the frypot and down the back. Element wires should be routed to the center of the frypot between the ATO temperature probes.

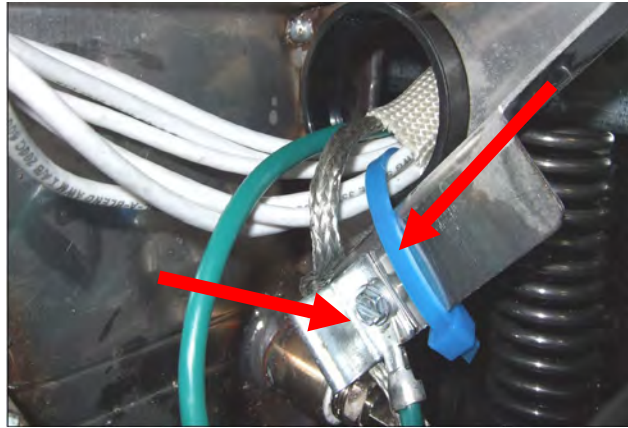
Figure 41

Element grounding and wire routing

To ground the element wires, use the hole in the frypot frame located under the bushing that the element wires pass through. Using a screw through the ground wires ring terminal, connect it to the frypot using the probe ground clip. Use a tie wrap to tie up half of the element wires after the wires are pulled through the bushing. Do not pull tie wrap tight, leave some slack in it about one inch in diameter to allow some movement.

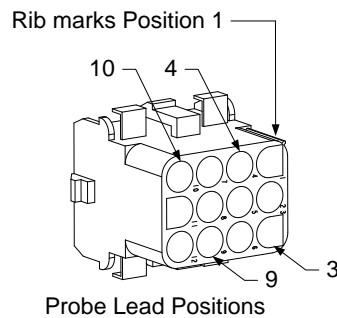
Figure 42

9. Reconnect the element connector ensuring that the latches lock.
10. Insert the temperature probe leads into the 12-pin wiring harness connector (see Figure 42). For full-vat units or the right half of a dual-vat unit, the red lead goes into position 3 and the white into position 4. For the left half of a dual-vat unit, the red lead goes into position 9 and the white into position 10. **NOTE: Right and left** refer to the fryer as viewed from the rear.

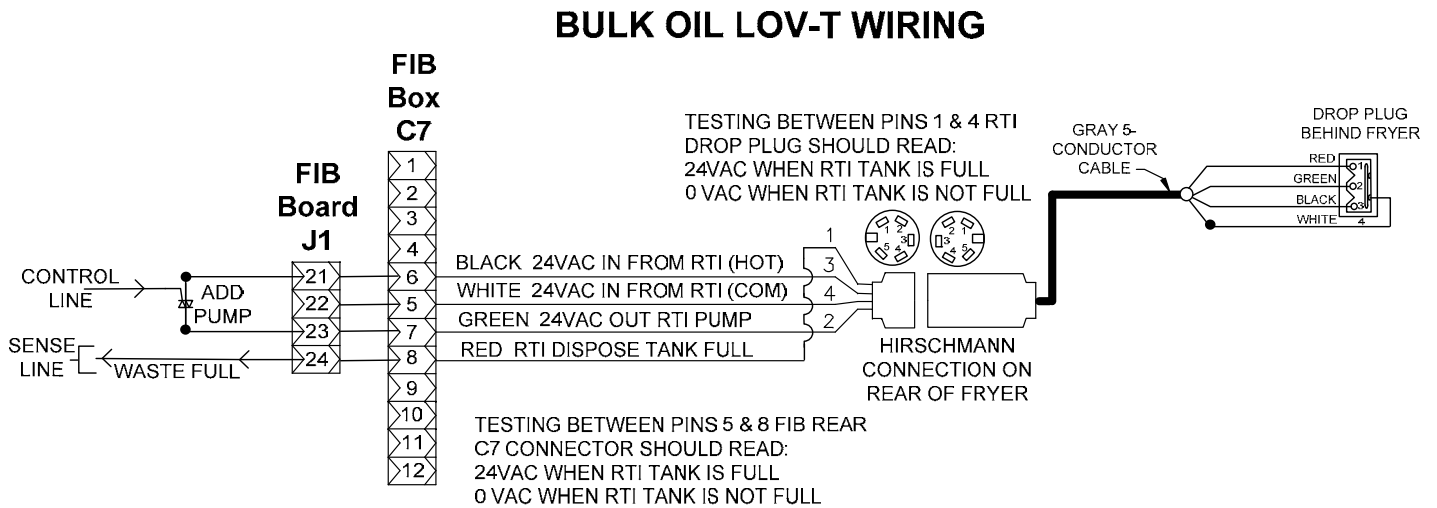
Figure 1

A.2 RTI LOV™ Wiring with RTI Switchbox

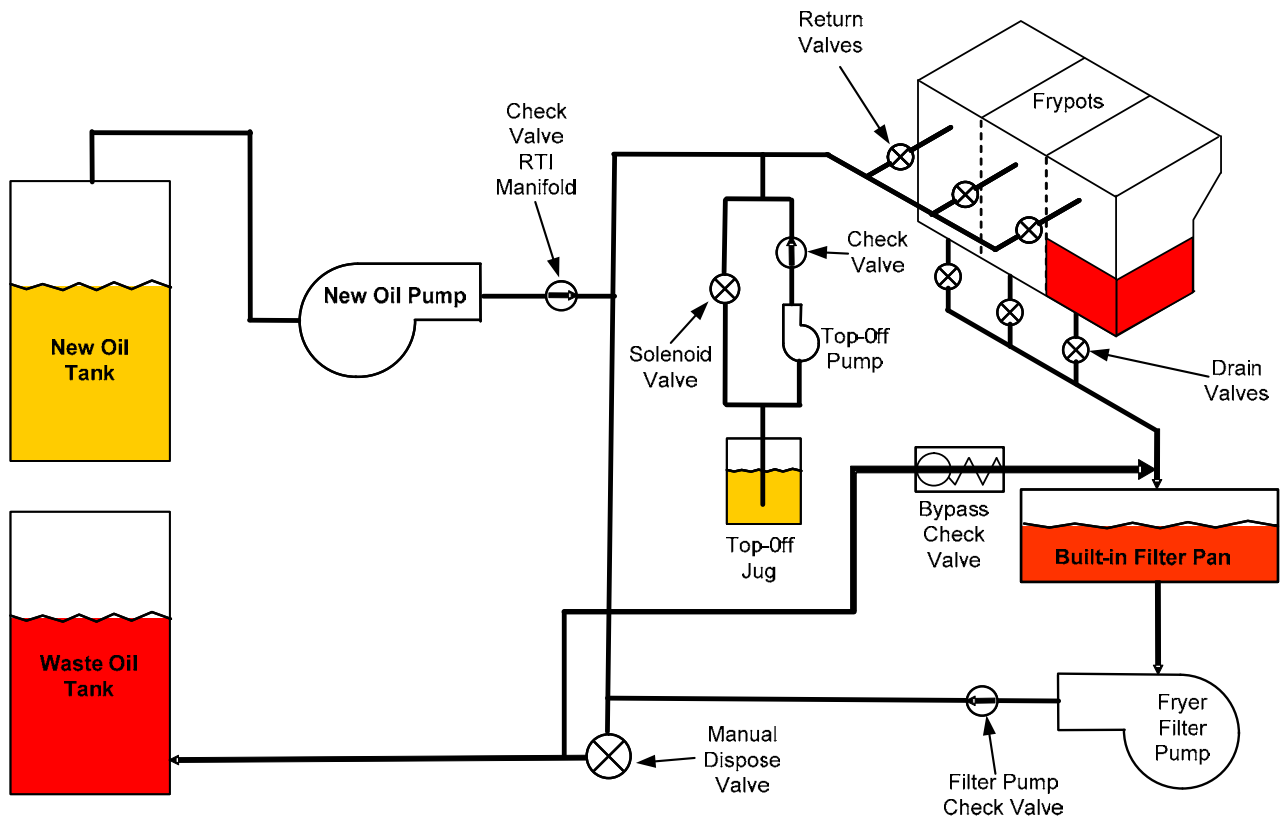
Figure 2

A.3 Frymaster LOV™ Fryer and RTI Bulk Oil System Plumbing Schematic
