BIELA14-T Series Gen III LOV™ Electric Fryer (Japan Only)

Service Manual

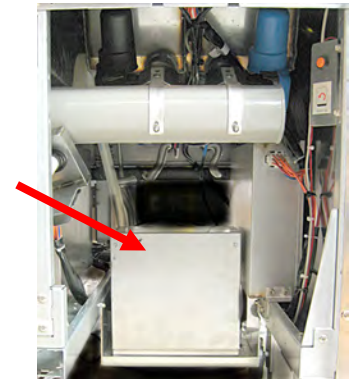
The FIB board is located inside the box, behind the right hand door (see Figure 17). The power for the FIB board and the filter pump relay are supplied from the 24VDC power supply in the FIB box. The 24VDC power supply also provides power, which passes through the FIB board to the VIB board, to the rotary actuators. The power for the VIB board microprocessor is supplied from the SIB.

Disconnect the fryer from the electrical power supply. Locate the FIB box (see Figure 17 in section 1.11), behind the oil reservoir). Remove the cover of the FIB box to expose the power supply, FIB board and optional SUI communication board (see Figure 21). Mark and unplug any wires or harnesses. Replace the defective component and reattach all wires or harnesses. Replace the cover. Once replaced, **CYCLE POWER TO ENTIRE FRYER SYSTEM**. See section 1.13 to cycle control power. Check software version and if necessary update the software. If a software update is necessary, follow the instructions to update the software in section 1.15.

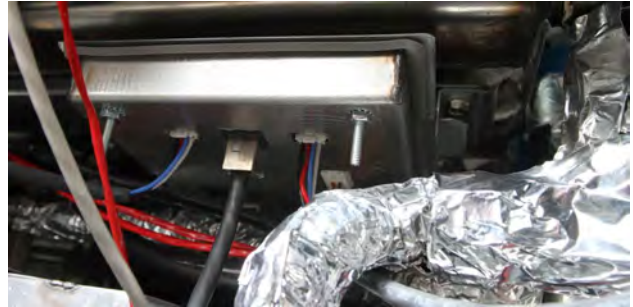
Figure 25

The VIB (Valve Interface Board) controls the actuators that open and close the drain and return valves. The VIB boards are located inside a protective housing under each frypot (see Figure 25).

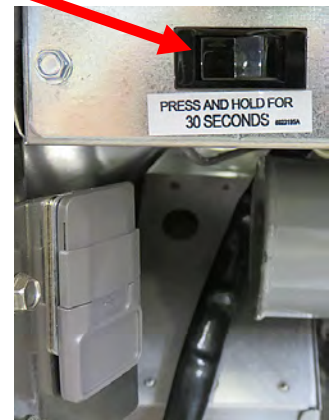
Figure 34

25. Cycle the fryer control power using the switch on the front of the left contactor box (see Figure 34). **ENSURE THE SWITCH IS TURNED OFF FOR 60 SECONDS.**
26. While the fryer is rebooting some controllers may take up to 10 minutes to reboot as the software is loading.
27. Once all controllers have returned to the power standby switch, go to the next step.
28. **VERIFY** software update by pressing the information (?) button; press the down arrow; press the SW version button. The controller displays INTIALIZING. Ensure that the M4000(UIB)/VIB/FIB/SIB software versions have updated.
