# Frymaster®

Your Growth Is Our Goal

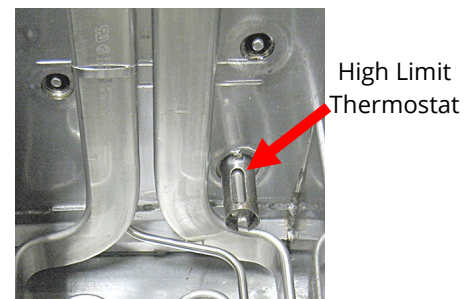
7. Insert the leads into the 12-pin connector C-6 (see Figure 3). For full-vat units or the left half of a dual-vat unit (as viewed from the rear of the fryer) the leads go into positions 1 and 2 of the connector. For the right half of a dual-vat unit (as viewed from the rear of the fryer), the leads go into positions 7 and 8. In either case, polarity does not matter.

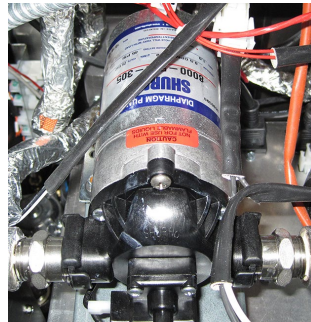
Disconnect the fryer from the electrical power supply. Locate the ATO pump (see Figure 22), behind the ATO box. Mark and unplug any wires or harnesses. Press down from the top on the quick disconnects to release the plumbing (see Figure 23). The plumbing can be pulled from the pump. Loosen the four nuts attaching the pump to the pump tray. Disconnect the electrical connection. Replace the defective component and reverse above steps. Once replaced, reconnect the power.

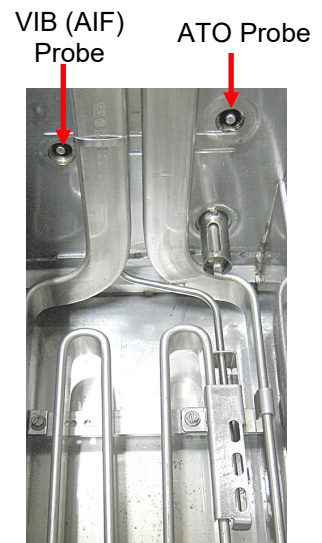
1. Disconnect the fryer from the electrical power supply and reposition it to gain access to the rear of the fryer.
2. Remove the associated side panel, if replacing an outside probe, to gain access to probe harness.
3. Drain cooking oil below the level of the probe to be replaced.
4. Disconnect the component wires as follows:
  - a. If replacing the ATO probe, disconnect them from SIB board.
  - b. If replacing the VIB (AIF) probe, use a paperclip to push pins from the J1 connector on the VIB board.
5. Unscrew the probe from the frypot.
6. Apply Loctite® PST56765 pipe thread sealant or equivalent to the replacement part threads and screw the replacement part into the frypot. If replacing an ATO or VIB probe **ensure the probe is flush with the side of the vat** prior to tightening. Torque the component to 180 inch-pounds.
7. Reverse steps 1 through 5 to complete the procedure.

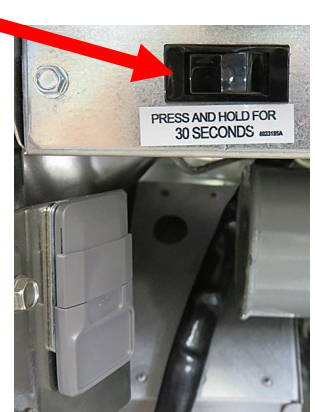
If the sides or ends of the frypot are coated with oil, the most probable cause is spillage over the top of the frypot rather than leakage.
