Frymaster[®]

Your Growth Is Our Goal

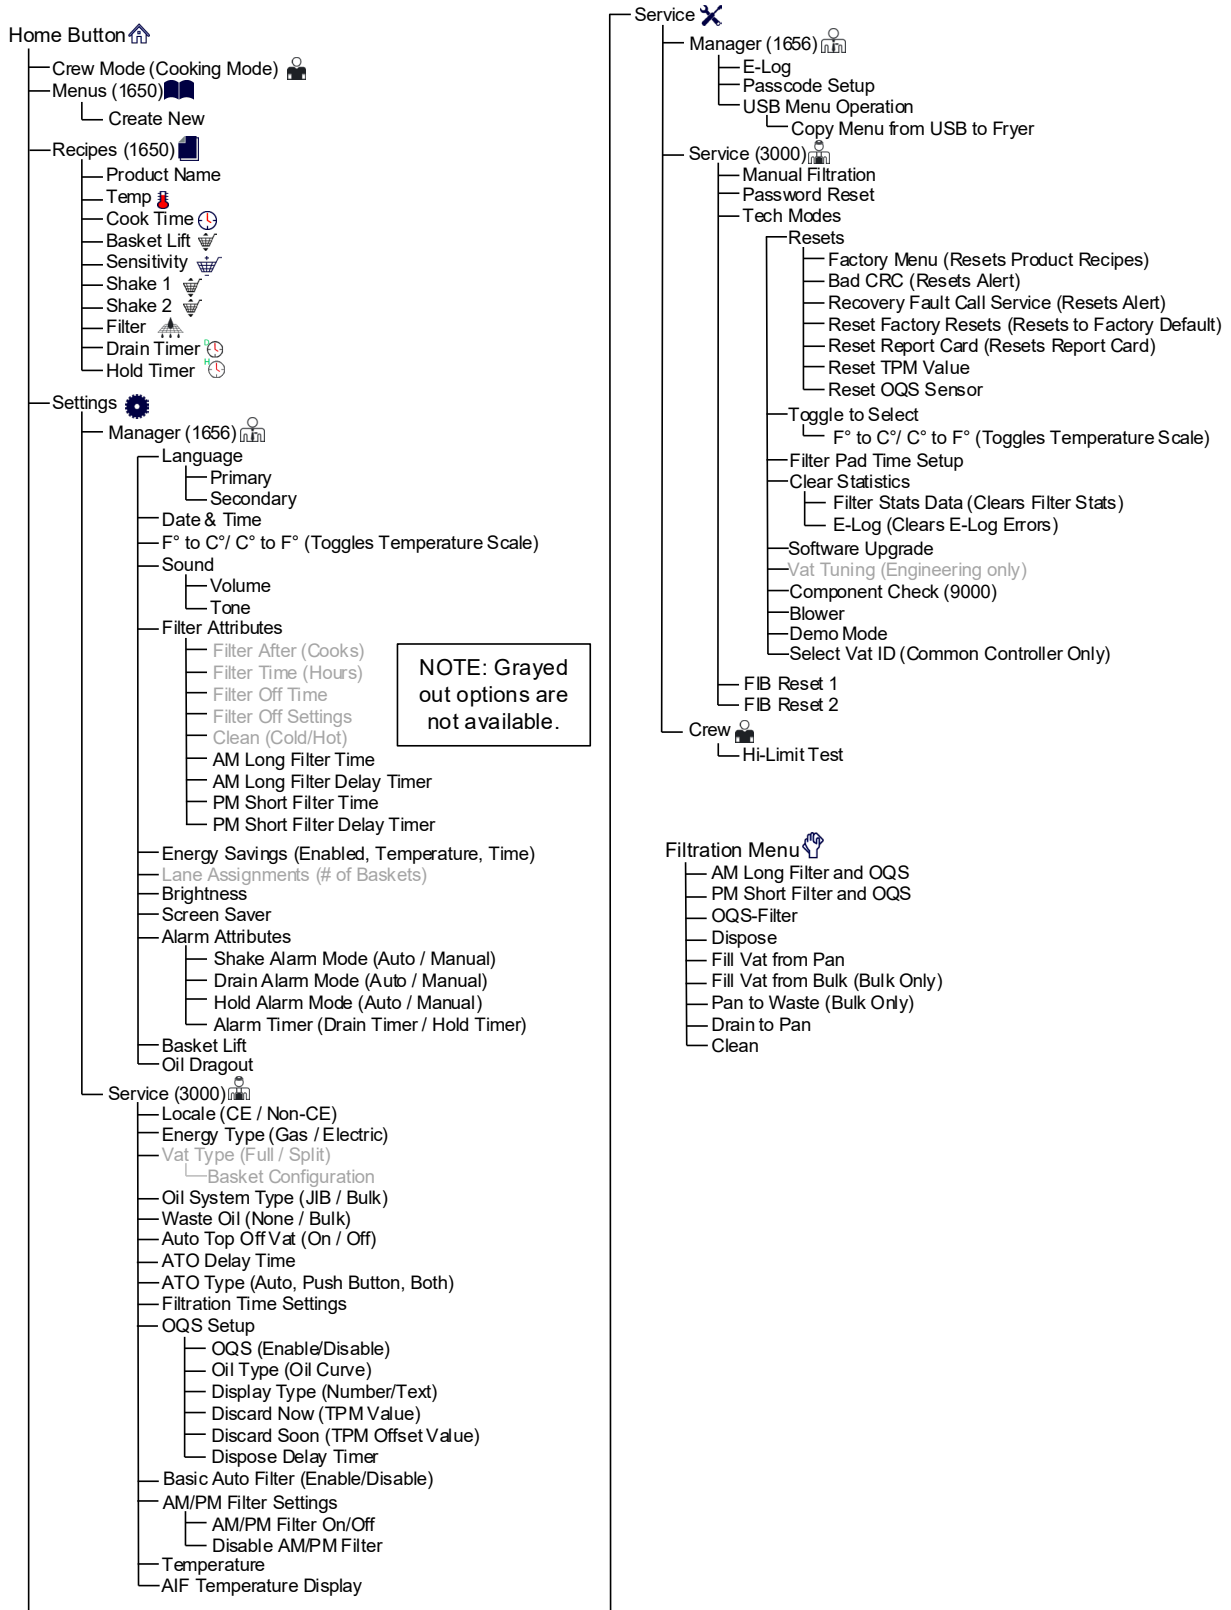
1.1.4 FQ4000 Information Statistics Menu Tree Taco Bell

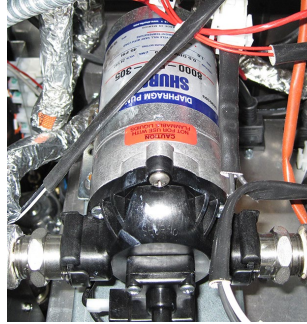
Disconnect the fryer from the electrical power supply. Locate the ATO pump (see Figure 33), behind the FIB box. Mark and unplug any wires or harnesses. Press down from the top on the quick disconnects to release the plumbing (see Figure 34). The plumbing can be pulled from the pump. Loosen the four nuts attaching the pump to the pump tray. Disconnect the electrical connection. Replace the defective component and reverse above steps. Once replaced, reconnect the power.
