Frymaster®

BIGLA30-T Series Gen III LOV™ Gas Fryer

Service Manual

Part Number: FRY_SM_8197546 02/2024

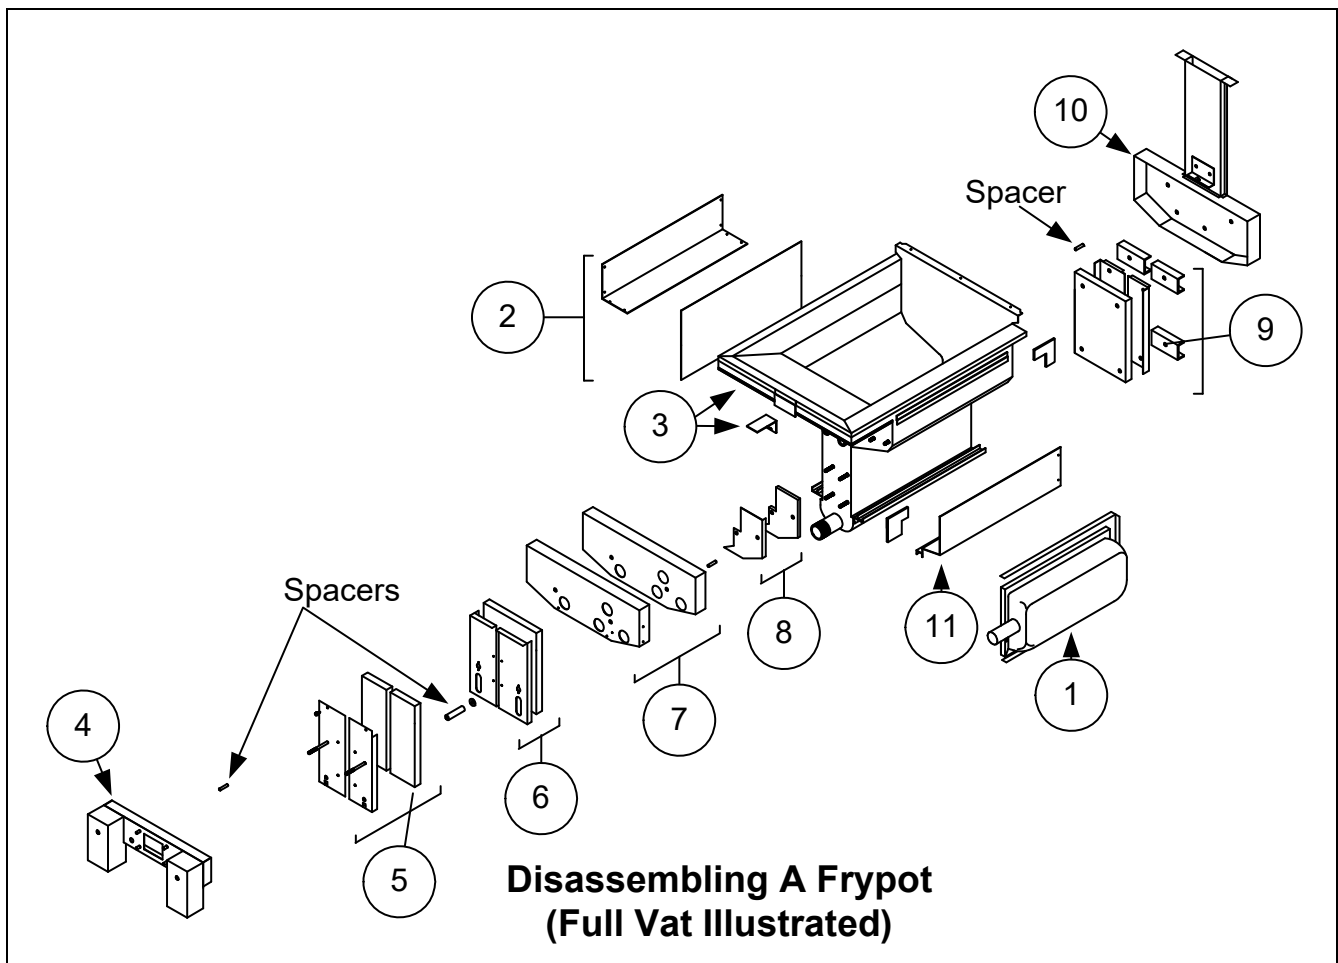
Figure 20 See page 1-26 for reassembly illustration.

10. Remove the flue assembly (10).

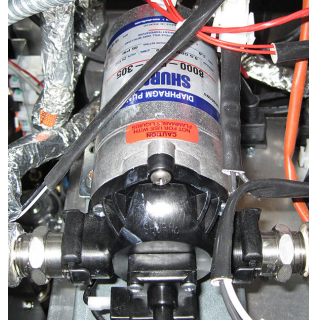
Figure 33

Disconnect the fryer from the electrical power supply. Locate the ATO pump (see Figure 33), behind the FIB box. Mark and unplug any wires or harnesses. Press down from the top on the quick disconnects to release the plumbing (see Figure 34). The plumbing can be pulled from the pump. Loosen the four nuts attaching the pump to the pump tray. Disconnect the electrical connection. Replace the defective component and reverse above steps. Once replaced, reconnect the power.

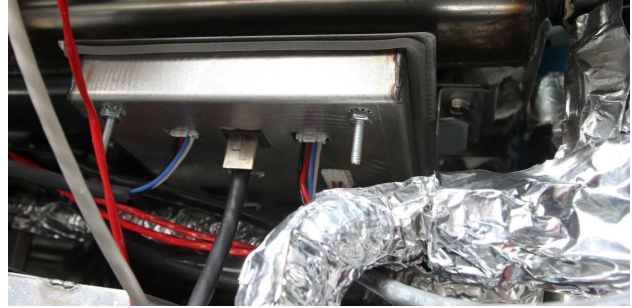
Figure 39

The VIB (Valve Interface Board) controls the actuators that open and close the drain and return valves. The VIB boards are located inside a protective housing under each frypot (see Figure 39).

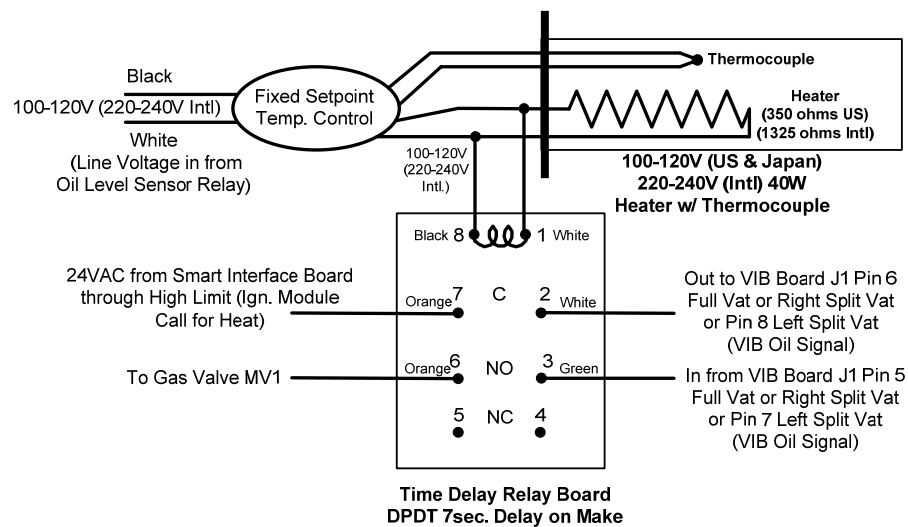
Figure 47

1.21.5.2 Oil Level Sensor Diagram
